Technical Reference - Q&A

1. Q: My P45 motherboard has two onboard LANs. How do I set the Teaming function and combine both onboard LANs to be a team with more bandwidth in my system?

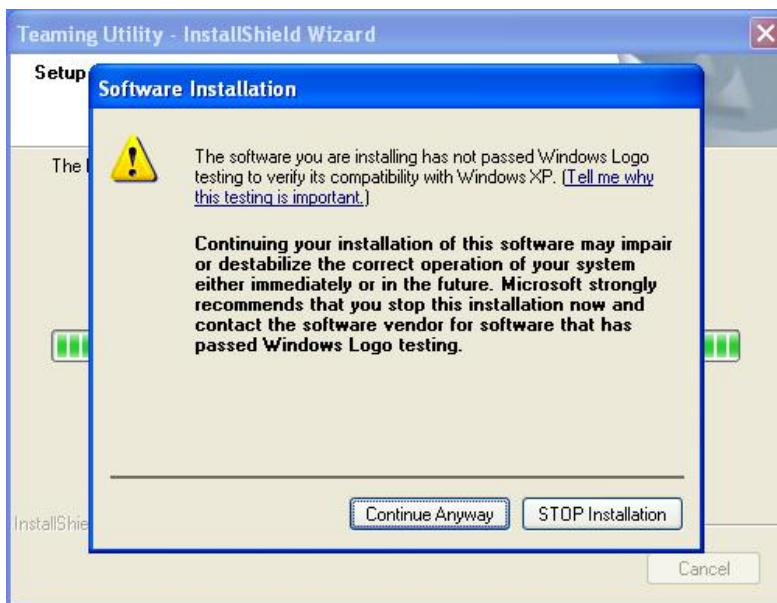
(*When installing teaming driver, system will show below warning message.

Please choose “Continue Anyway” and keep installing driver.)

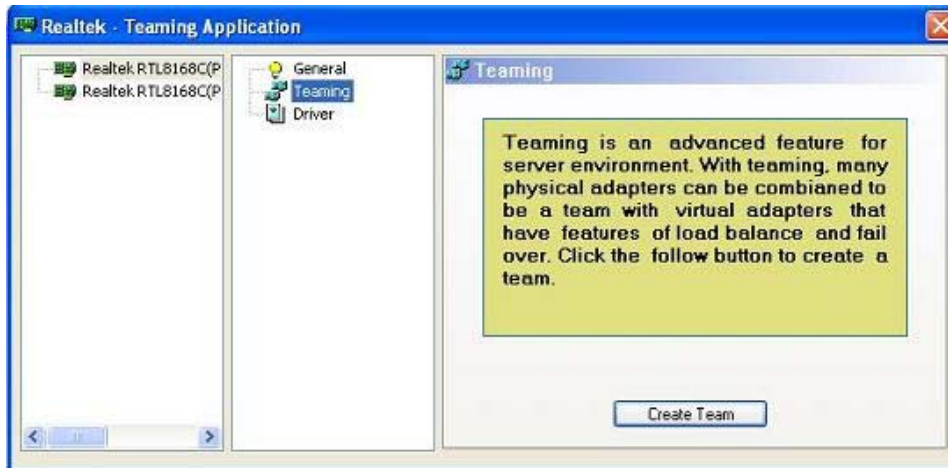
3. Click “Teaming” item and then press “Create Team” button.

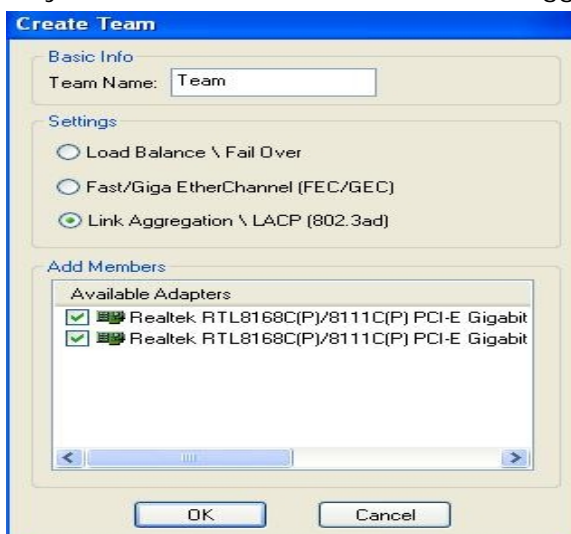
4. Key in Team Name and choose "Link Aggregation \ LACP (802.3ad)" for Settings.

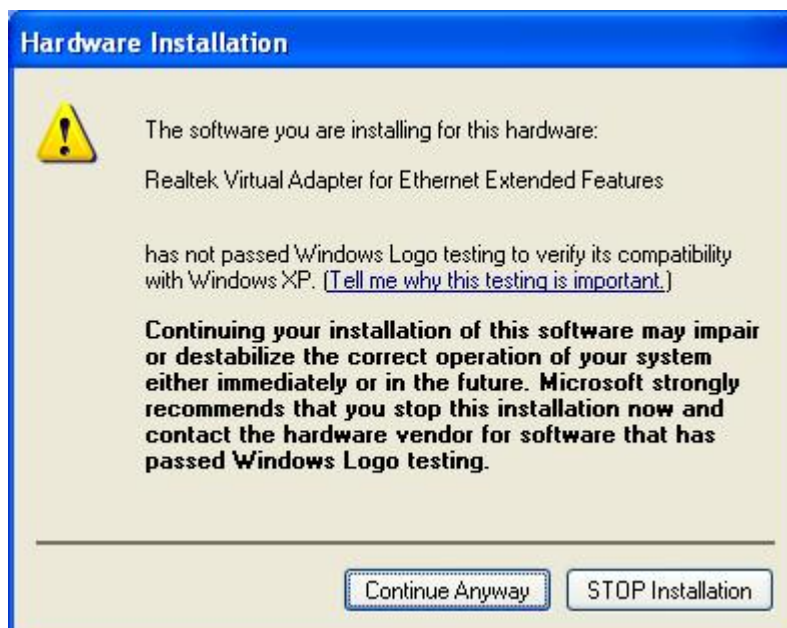
5. Select two available onboard LAN cards and then press "OK" button (After pressing "OK" button, system will show below warning message. Please choose "Continue Anyway".)
